Labor and Material Report April 27 1929

8 Horcau Ave

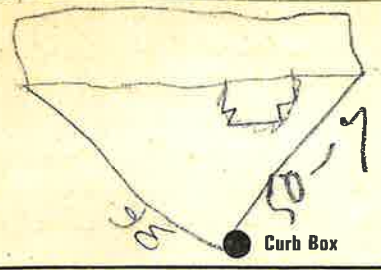
6 Main Eley of Main at tap 1/2  
 Gate at ● Gate at ●

● Curb Box  
 old tap disconnected  
 2 holes in str to  
 be repaired  
 stop shows  
 off when on
