29-54

26413 May 14

**Labor and Material Report** 19 22

18 Hudson Ave.

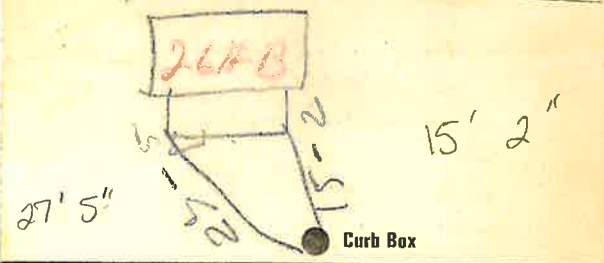
6 Main Eley of Main at tap 2 1/2

Gate at ● Gate at ●

● Curb Box

Old tap to be dug up  
Shutoff at curb  
Dec-27-1972
