### Labor and Material Report

Aug 23 1930

105 Hunter + B... Ave

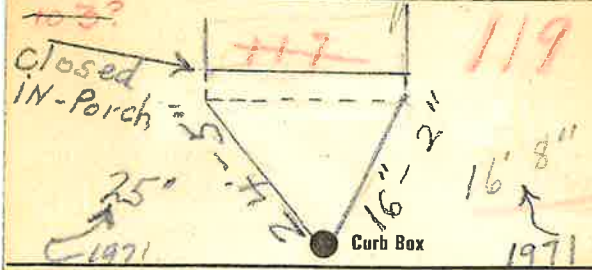
Main Elev of Main at tap 4.5  
Gate at ● Gate at ●

● Curb Box

*new sand cover of  
punter of curb box  
and*
