3-21-1930

**Labor and Material Report**

7-9 Hunter St

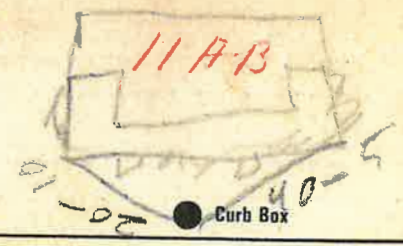
4 Main

Curb Box

Old tap disconnected
