LABOR AND MATERIALS

Name of Owner
Lapham
First National Bank

Labor and Mat'l. Report Aug 30 1949

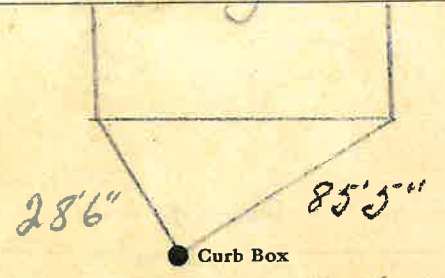
● Curb Box
Lapham Pl. side.
Elev. of Main at tap 5 1/2

3 Main Gate at ● ● Gate at

● Curb Box
