# LABOR AND MATERIALS

1 Leland Dr

Labor and Mat'l. Report ~~10~~ 10 / 2005

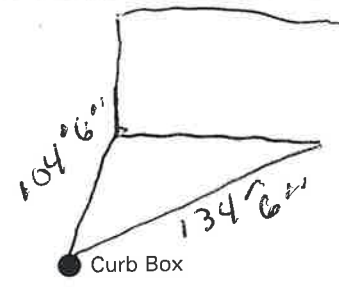
6 Main

Elev. of Main at tap 4

● Curb Box
