# LABOR AND MATERIALS

LeLan DR. St. \_\_\_\_\_  
 Pl. \_\_\_\_\_  
 Ave. No. 5

Labor and Mat'l. Report ~~10~~ 4/19/06

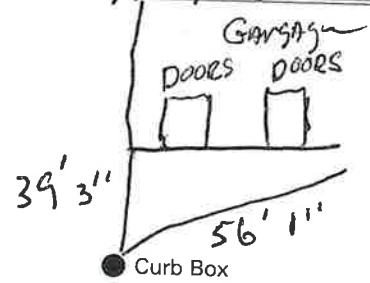
6" Main

Elev. of Main at tap 6

(Look AT Bu) ● Curb Box

Sewer line 1' LEFT OF  
 WATER 6" LINE TEN FEET  
 DEEP SEWER MAIN 17'  
 OFF CURB BOX
