St. ~~Pl.~~ Ave. No. 34

Labor and Mat'l. Report

19 90

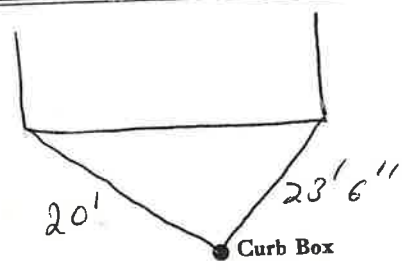
6" Main

Elev. of Main at tap 5'

● Curb Box

Curb box - 4' depth
