St. \_\_\_\_\_  
Pl. \_\_\_\_\_  
Ave. No. 44

Name of Owner  
Adelbert Wells Est.

Labor and Mat'l. Report May 12 1969

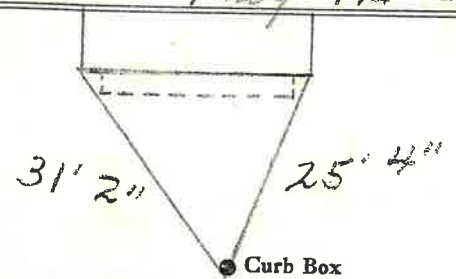
6" Main                      Elev. of Main at tap 5'  
Gate at ●                                      ● Gate at

● Curb Box  
Tap made due to  
leak at main.
