Labor and Material Report June 23 1911

Tap on Crandall
ST.

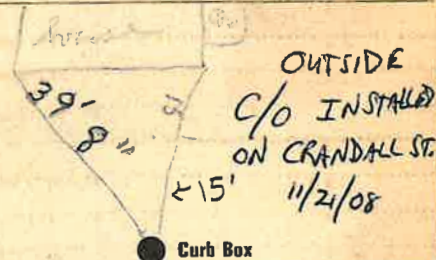
CRANDALL ST

10" Main

Elev. of Main at tap 5'

● Curb Box

NOTE - REVERSE BOX -
"ON" POSITION IS OFF
