Labor and Material Report

Oct 20 19 20

3/4" 16 Locust

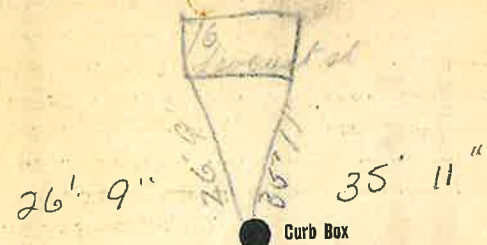
*Dug up & Found to Be Copper 11/8/76*
