St. **27**
 Pl.
 Ave. No. **21**

Name of Owner
 TAX ID # 302.16-4-18

Labor and Mat'l. Report 19

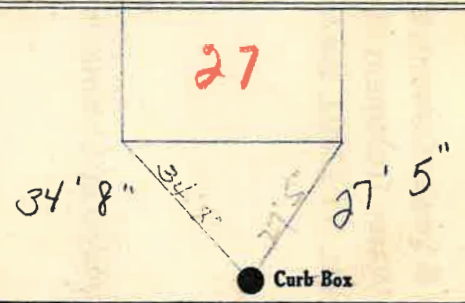
6" 1960 Main Elev. of Main at top 5'

Gate at ● ● Gate at

● Curb Box
