Dr. McArthur  
 Sr. 33  
 Pl. 33  
 Ave. No. 33

Name of Owner Frank Collins

Labor and Mat'l. Report Aug. 25 1960

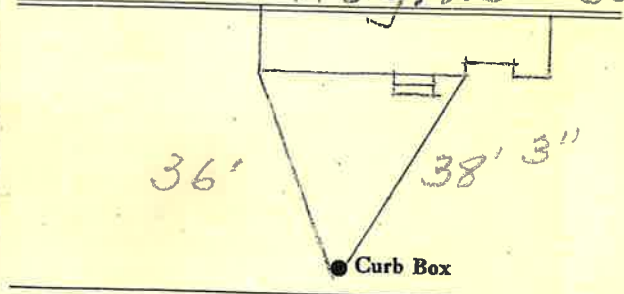
12" Main Elev. of Main at tap 5 1/2"

Gate at ● Gate at ●

● Curb Box
