Dr.
 St.
 Pl.
 Ave. No. 56

Name of Owner
 Sol DeGennaro

Labor and Mat'l. Report Dec. 8 1965

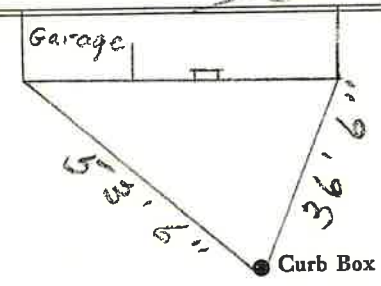
12" Main Elev. of Main at tap 4 1/4
 Gate at • Gate at •

• Curb Box
