St. PL- Ave. No. 135

Name of Owner
Marzola

Labor and Mat'l. Report 4-12- 1951

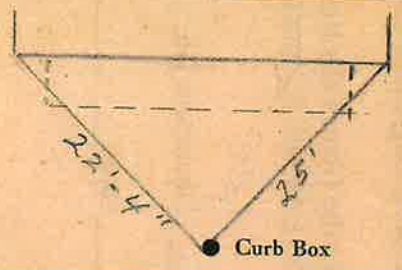
6" Main Elev. of Main at tap 5'

Gate at ● Gate at ●

● Curb Box
