30-143
Labor and Material Report July 24 1930

155 9th St

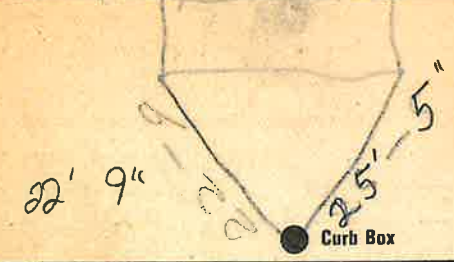
6 Main Eley of Main at tap 6

Gate at ● Gate at ●

● Curb Box

old tap disconnected

Disconnected at main.

Pipe Broken by Contractor laying gas main.
