Maple St. Pl. Ave. No. 160
 Name of Owner

Finch, Pruyn & Co.

Labor and Mat'l. Report Nov. 19-23 1968

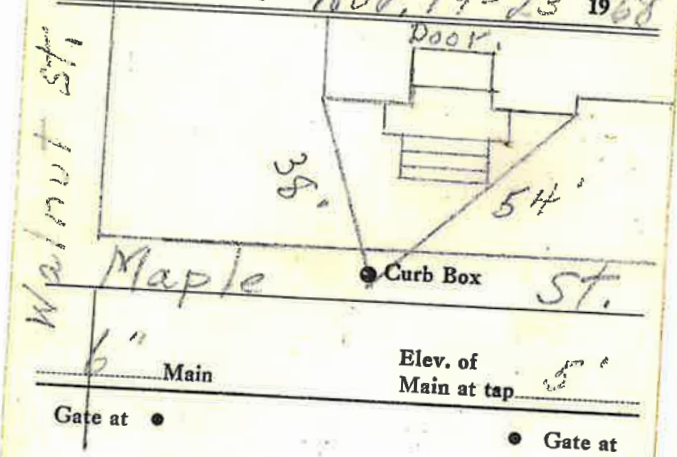
6" Main Elev. of Main at tap 5'
 Gate at • Gate at •

• Curb Box
 6" Sprinkler System
 Tap.
