McDonald St. No. 76

Name of Owner
 Lorenzo Coon

Labor and Mat'l. Report MAY 18 1973

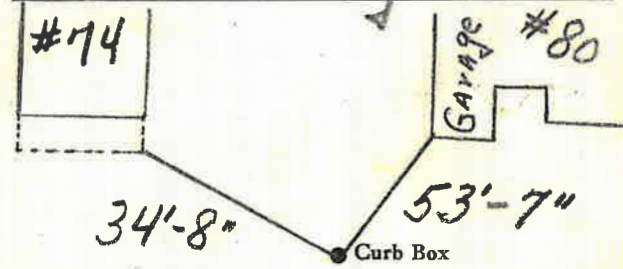
4" 8" 1975 Main Elev. of Main at tap 5 1/2'

Gate at • • Gate at

• Curb Box
