Labor and Materials

Copper line Replaced Total \$ 23.24

Labor and Material Report

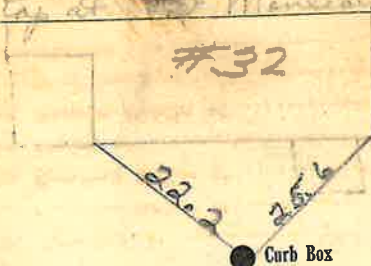
3/4" tap at <sup>Aug 10</sup> ~~at~~ <sup>Manhole 54</sup>

10" Main

Elev of Main at tap 6

old tap what off at main.
