#44

Labor and Material Report May 20 1933

2 Bodgen St

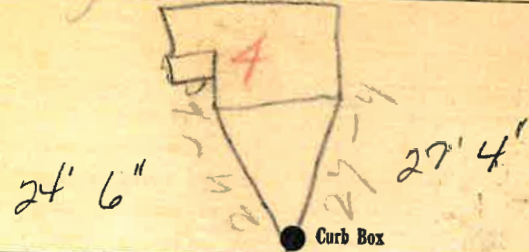
Main Elev. of Main at tap 6  
 Gate at ● Gate at ●

● Curb Box

old Tap to be chng up
