Labor and Material Report

17 Aug 13 1936
17 Ogden St

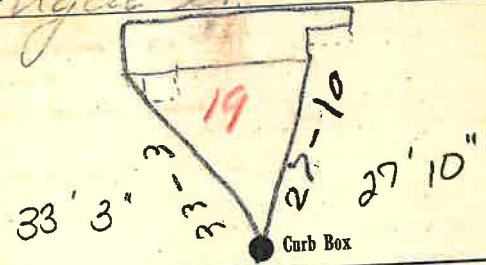
4 Main

Elev of Main at tap 5 1/2

26' 10" 40'

• Buffalo Box
line dead?

found Aug. 2000
