St. Orchard
~~Pl.~~ Ave. No. 56

Name of Owner Ron Gindler

Labor and Mat'l. Report Oct 19 88

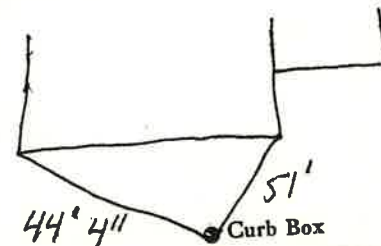
Main Elev. of
Main at tap

Gate at • • Gate at

• Curb Box
