St. Orville  
 Pt. 37  
 Ave. No. 37

Name of Owner Johns.

Labor and Mat'l. Report Feb, 21 1963

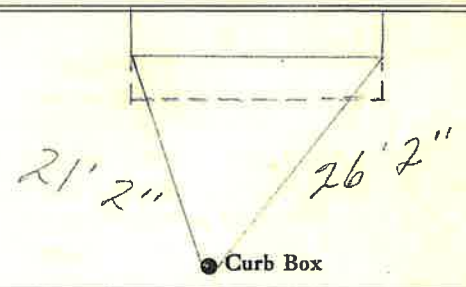
6" Main Elev. of Main at tap 5'  
 Gate at • Gate at •

• Curb Box  
 TAX ID# 309.27-1-15
