PECK St. Ave. No. 33
 Ave. No.

Name of Owner JIM GREENWOOD

Labor and Mat'l. Report 10/20/2007

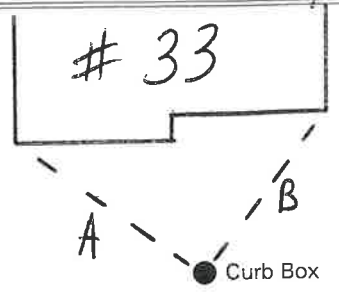
6" Main Elev. of Main at tap 4'

● Curb Box
 A = 41'
 B = 35'
 SEWER MAIN 24'
 FROM CURB BOX
