St. _____
Pl. _____
Ave. No. 58

Name of Owner
LARRY CLUTE

Labor and Mat'l. Report 1999

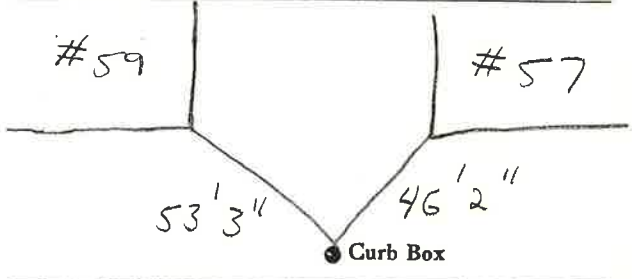
6" Main #58 Elev. of Main at tap 5'

Gate at ● ● Gate at

● Curb Box
