Prospect

St. Pl. 83-85  
Ave. No.

Tony A. Joseph

Labor and Mat'l. Report

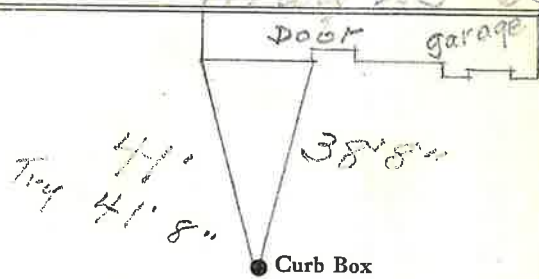
6" C.I. Main

Elev. of Main at tap 5'

• Curb Box

3/4" copper  
35' to main
