Labor and Material Report

Apr 20 1933

40 1/2 Inade St  
Goodman St

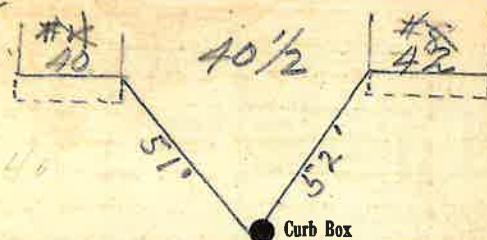
3/4" COPPER  
Tot. 10' to MAIN

Varney,  
Measurements taken  
from #4 & 8 for  
empty lot. #6
