St. Ave. No. 15

Quade
Name of Owner City School Dist.
Administration Bldg.

Labor and Mat'l. Report July 1 1964

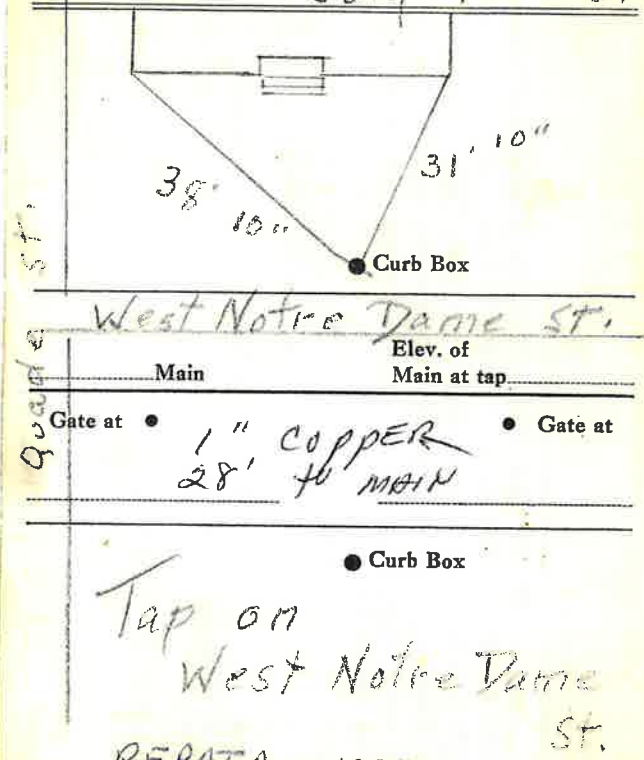
COPPER LOOPED NEAR ROAD SURFACE

REPAIR - 1999
