St. _____
 -Pl. _____
 Ave. No. 35

Name of Owner
Quade
John Glass.

Labor and Mat'l. Report Aug. 11 1959

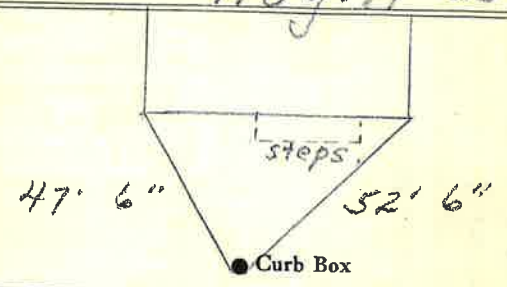
6" Main Elev. of Main at tap 5'
 Gate at • Gate at

• Curb Box
