Reservoir St. D1. ✓  
Pl. Ave. No. 7

Name of Owner  
Hay

Labor and Mat'l. Report June 14 1957

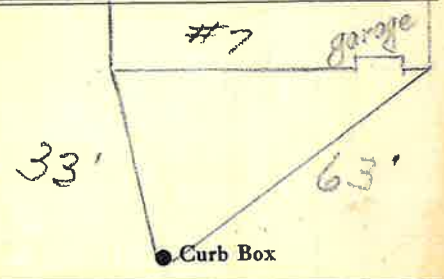
Transite  
6" Main Elev. of Main at tap 4 1/2'

Gate at • Gate at  
TAX ID # 302.17-4-10

• Curb Box

Repaired water main break  
Sept. 8, 2009 @ this address  
Main in middle of the Road
