Labor and Material Report

33 Sagamore St

27-110 Labor and Material Report July 7 19 27

39 Sycamore St.

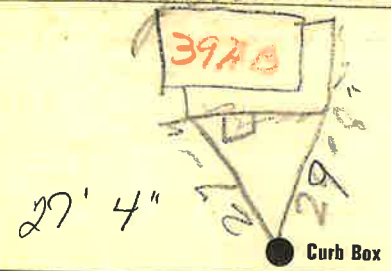
Old tap dis connected.

7' to main  
3/4" copper
