SANFORD St. No. 201 Ave. No.

Name of Owner Wm. BANNON

Labor and Mat'l. Report July 18 1974

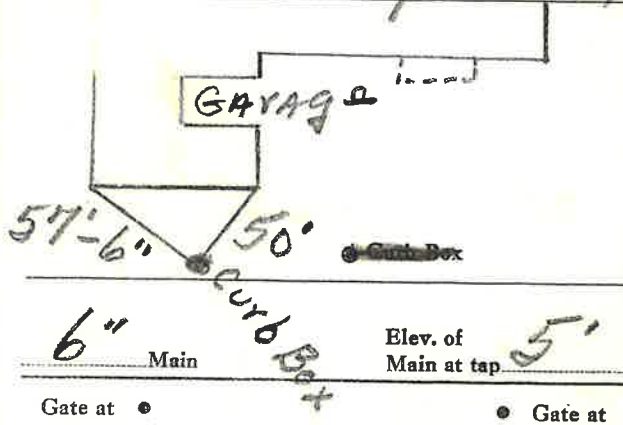
23' to MAIN  
3/4" copper
