St. Sanford
~~Pl.~~
 Ave. No. 212

Name of Owner
O'lick

Labor and Mat'l. Report 1970

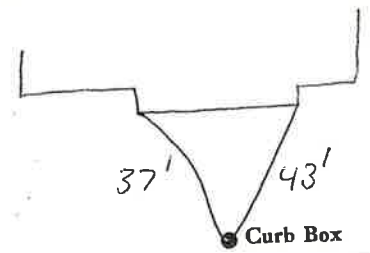
• Curb Box
14' to main
3/4" COPPER
