221 Sanford

TAX ID # 303.9-18-6

Labor and Mat'l. Report 19

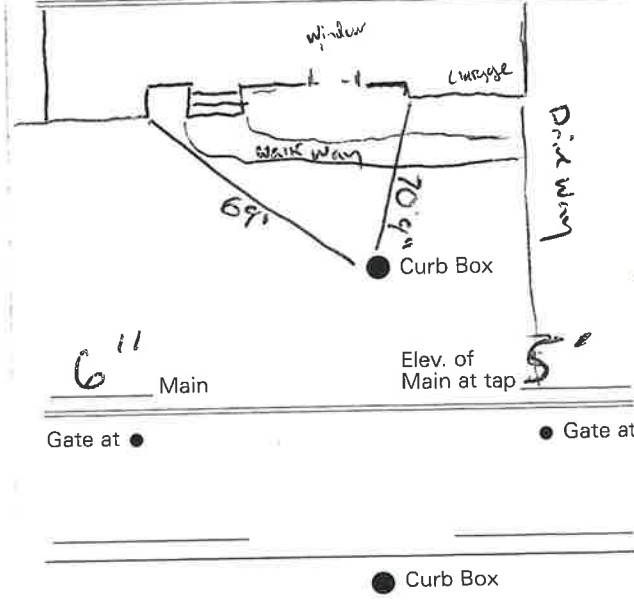
6" Main      Elev. of Main at tap 5'

● Curb Box
