88 SANFORD St.
Pl. Ave. No.

Labor and Mat'l. Report 19

31-226
Labor and Material Report Nov. 5 1931

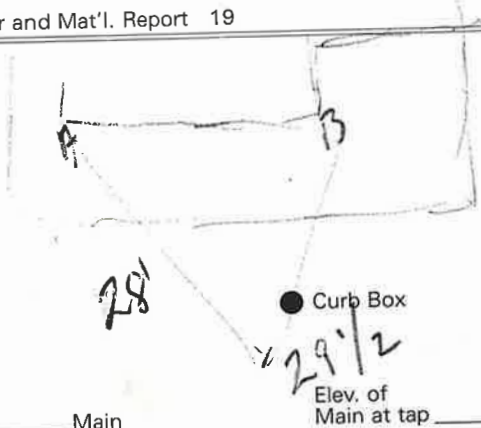
old taps dis-
connected.

10' to MAIN
3/4" COPPER
