✓
 Sanford St. No. 157
 Ave. No.

Name of Owner Mac Naughton

Labor and Mat'l. Report Oct. 17 19 58

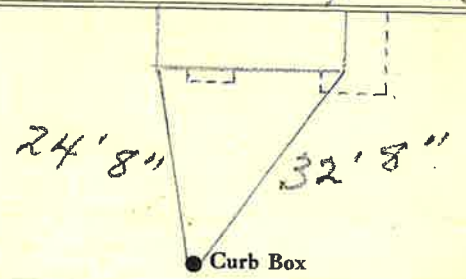
6" Main Elev. of Main at tap 5 1/2'
 Gate at • Gate at

• Curb Box
 24' to main
 3/4" COPPER
