St. Sanford
 Pl. Ave. No. 173

Name of Owner
 Ray Bennett.

Labor and Mat'l. Report Nov. 27, 1963

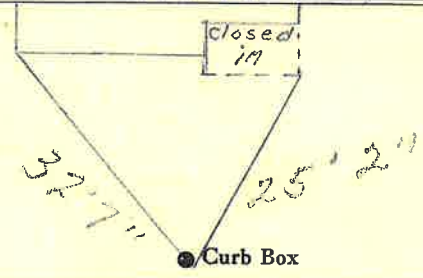
6" Main Elev. of Main at tap 4'
 Gate at • Gate at

• Curb Box
 TAP ON SIDE OF
 MAIN
 24' TO MAIN
 3/4" COPPER
