Second St. Ave. No. 49

Name of Owner  
Goldstein

Labor and Mat'l. Report Oct. 14 1954

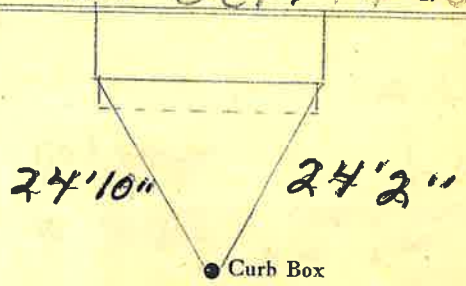
6" Main Elev. of Main at tap 5'

10' to MAIN • Curb Box

3/4" COPPER

Old Tap disconnected at Main Oct 14-54
