Labor and Material Report

143 Sherman Ave

Labor and Mat'l. Report

Nov. 25 1952

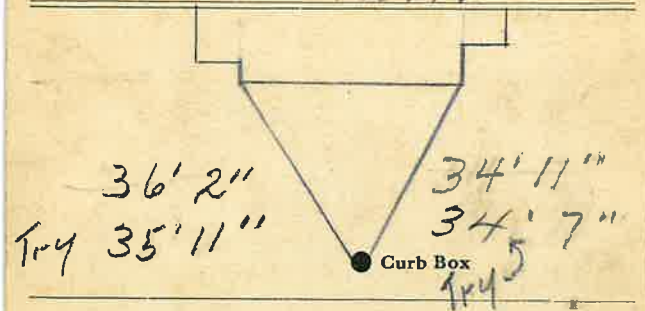
25' to MAIN

3/4" COPPER

This tap made
to take place of one
in intersection of
Sherman & Clayton
Avenues
