Labor and Material Report Aug 11 1923

1/2" tap at 8 Sherman Ave

~~St.~~  
~~#~~  
Ave. No. 8

Labor and Mat'l. Report Dec 8 1977

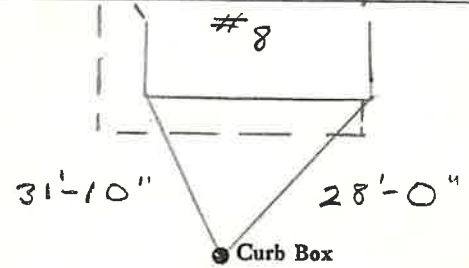
6" Main

Elev. of Main at tap 5'

9' to main  
3/4" copper
