St. _____
 Pl. _____
 Ave. No. 17-19

Name of Owner
 Jack - Marks Realty

Labor and Mat'l. Report Nov. 14 1970.

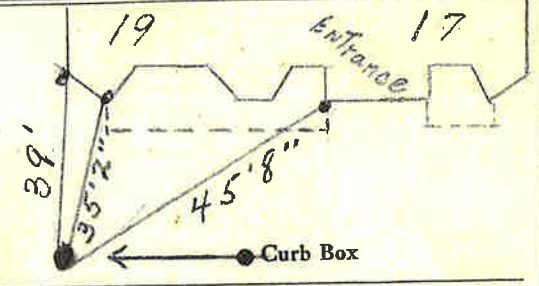
6" Main Elev. of Main at tap 5'
 Gate at • Gate at

• Curb Box
 30' to main
 $\frac{3}{4}$ " copper
