St. Shippey  
 -Pl.  
 Ave. No. 10

Name of Owner \_\_\_\_\_  
 TAX ID # 302.19.25.60

Measurements from Sanborn Map  
 Labor and Mat'l. Report Aug. 13 1970

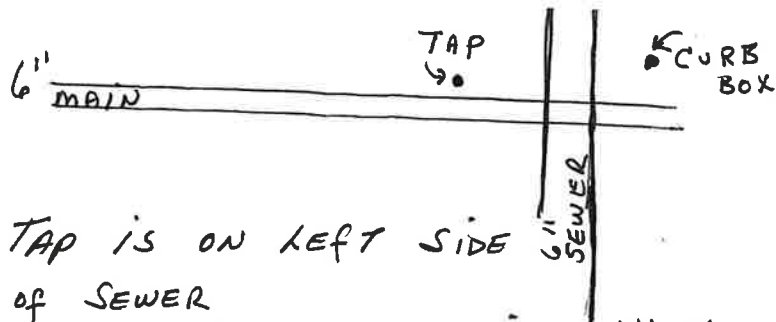
TAP IS ON LEFT SIDE  
 OF SEWER  
 CURB BOX IS ON RIGHT SIDE WITH 2'  
 COPPER, ABOUT 1' FROM MAIN WHICH IS  
 RIGHT UNDER THE CURB.
