St. ~~Pl.~~ Ave. No. 211

HARRY GATES

Labor and Mat'l. Report

AUG. 17 1934

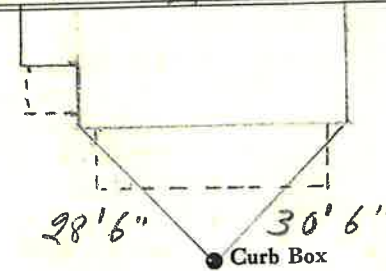
6" Main

Elev. of Main at tap $4\frac{1}{2}$

29' to CORY 1965.
 $\frac{3}{4}$ " COPPER

• Curb Box
BOX IN TREE STOP WASTE
CURB COCK SHUTS OFF TO
THE LEFT
