South ST St. Pl. Ave. No. 7

Name of Owner SPRINKLER LINE

Labor and Mat'l. Report ~~to~~ 2011 10/5/11

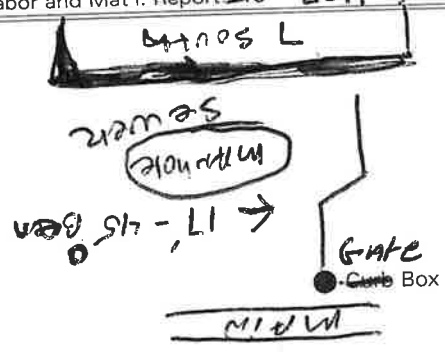
10" Main Elev. of Main at tap 6
 Gate at ● Gate at ●

● Curb Box
 REPAIR 45° BEN
 AND 6" PIPE
