**Labor and Material Report**

1930

132 SOUTH  
88 South Street (132)

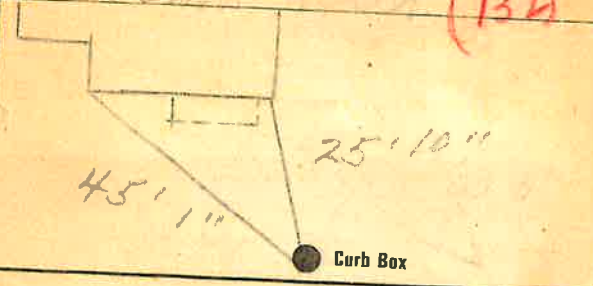
10 Main  
Elev of Main at tap  
Gate at ● Gate at ●  
9' to MAIN  
3/4" COPPER  
● Curb Box

Old Tap disconnected  
cut in new stop  
on their pipe  
8-22-62,
