E. STATE St. Pl. Ave. No. 16

Name of Owner \_\_\_\_\_  
TAX ID # 309.16-17-23

Labor and Mat'l. Report 10/28/2010

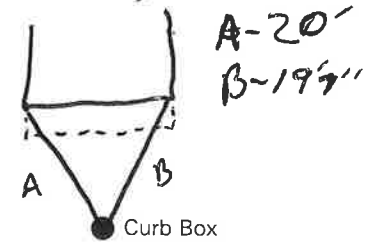
6" Main Elev. of Main at tap 4'8"

32' 6" curb box to main  
24' 6" SEWER LATERAL
