# LABOR AND MATERIALS

EAST STATE <sup>St</sup> 18 EAST  
 Pt. STATE St.,  
 Ave. No. \_\_\_\_\_

TAX ID # 309.16-17-7.4

Labor and Mat'l. Report <sup>to</sup> Aug. 31 2002

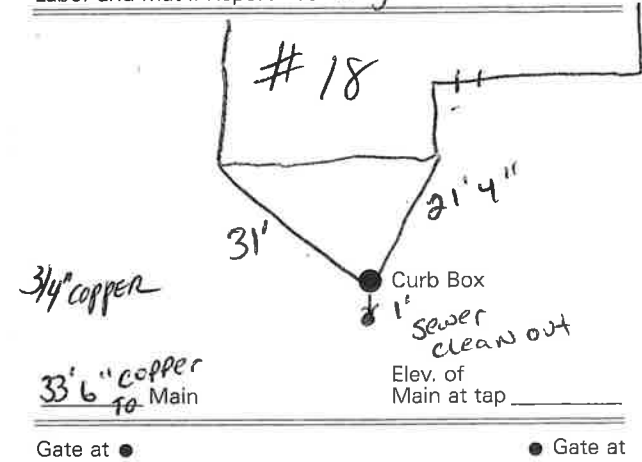
Sewer  
 24'3"  
 From main to  
 outside clean out

9FT Deep  
 SEWER
