W. State St. Ave. No. 13  
 Name of Owner Cifone

Labor and Mat'l. Report 1992

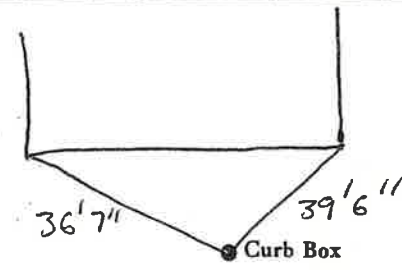
Elev. of
Main	Main at tap
Gate at ●	● Gate at
¾" copper	11' to MAIN

● Curb Box
