LABOR AND MATERIALS

St. Third
~~Pt.~~
 Ave. No. 16

Name of Owner
Charles Maurer

Labor and Mat'l. Report August 31 1978

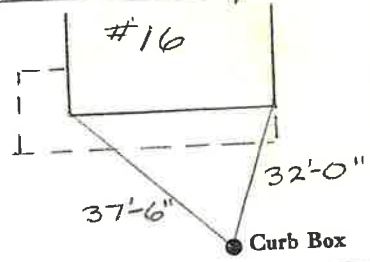
Main Elev. of Main at tap 5'

Gate at • • Gate at
 $\frac{3}{4}$ copper 22'6" to main

• Curb Box
