C.R.N. THOMAS + THIRD
THIRD St. No. 104
 Name of Owner 10 Thomas
TAX ID # 309.11-9-9

Labor and Mat'l. Report 19 85

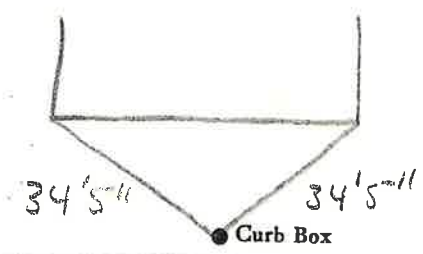
THIRD ST.
 Elev. of Main at tap _____
 6" Main
 Gate at • Gate at
26'6" to main

10 Thomas St • Curb Box
 TAP ON 3RD ST.
